## ON THE SIDE OF THE ANGELS

Landscape architects restore the Olmsted Woods at the Washington National Cathedral.

By Linda McIntyre

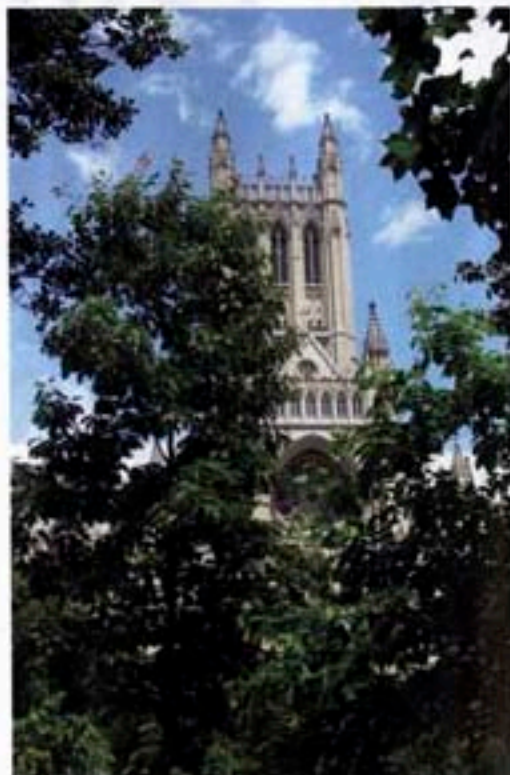
**Pilgrim Way, above, installed as part of the Olmsted Woods restoration, leads visitors through the woodland to the Washington National Cathedral. The cathedral, right, looks out over the city through the woods' tree canopy.**

Pilgrim Way, constructed of cut flagstone with a rain gutter of mortared river stones and stretches of a stabilized aggregate product called NaturalPAVE, was completed in 2000. This path was carefully laid out to take advantage of gaps from lost trees and minimize additional damage to the landscape, according to Andropogon landscape architect Marita Roos, ASLA. To avoid further compacting the soil and damaging tree roots, the construction was done mostly by hand. The path was built on existing soil, without excavation, and soil was aerated to protect tree roots.

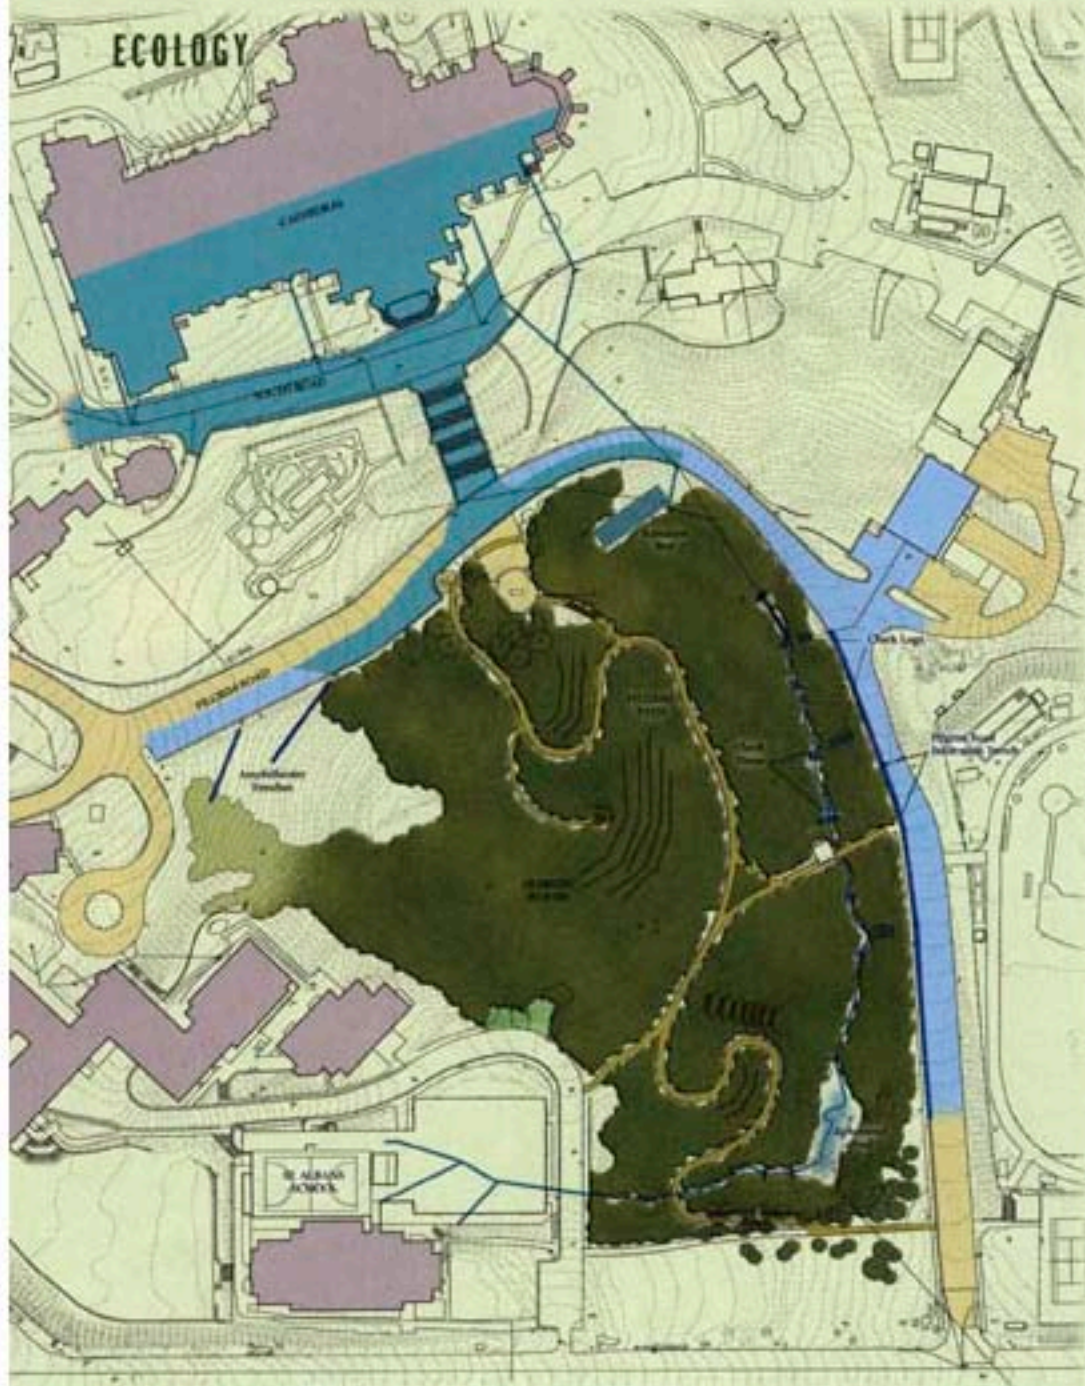
The stormwater management plan shows how runoff was slowed and dispersed by measures including a large infiltration bed on the north side of the site, check dams, and infiltration trenches along Pilgrim Road.

Phase two of the project, water management and stabilization of the ravine, was completed in 2002. The existing network of drainpipes had been positioned along Pilgrim Road, which follows the edge of the Olmsted Woods along the north and east sides. The network was dotted with infiltration trenches made of flexible perforated pipe so that water could seep back into the soil. A 20-foot by 70-foot Rainstore brand catch basin, comprising a series of vertical columns made of recycled resins, was installed at the top of the ravine, on a site where no trees had to be taken down, to capture runoff from the cathedral roof and release it slowly, creating ephemeral pools. Stone check dams and cedar logs were placed along swales, creating weirs to stanch the flow of stormwater and allow it to filter gradually into the soil.

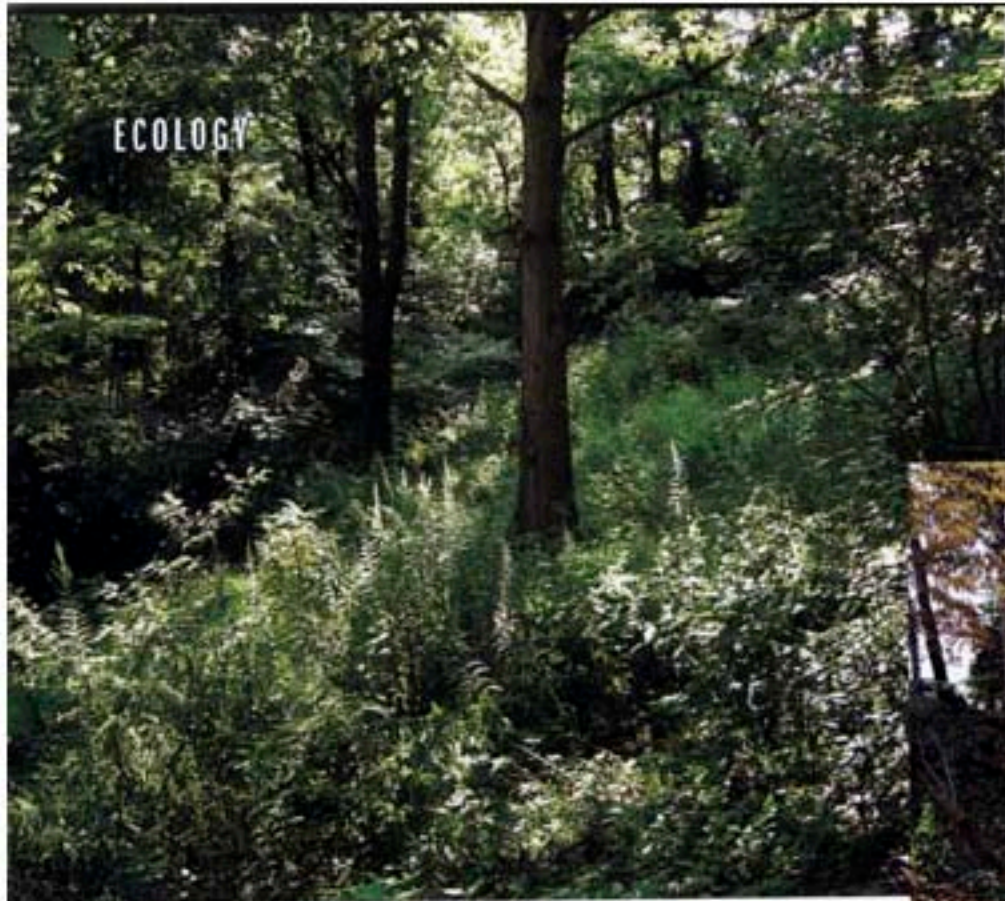
While the problem was not limited to stormwater, heavy rains underscored the runoff issues.

Perhaps the worst damage, though, was done by water. After storms and heavy rains, runoff from the paved road and parking areas, the paved area immediately surrounding the cathedral building, and the cathedral roof (about 37 percent of the area draining to the ravine was impervious) would fill a ravine running through the east side of the woodland with 10 or 12 feet of water, according to project cochair Anne Elsbree. EPA guidelines characterize a stream channel as "stressed" when its drainage area has an impervious surface area of more than 10 percent, and they indicate that when that level rises to more than 20 percent it's virtually impossible to maintain a natural stream and woodland ecosystem. The ravine itself was a product of poor water management—engineers working on the restoration say it started out as a swale 100 years ago, says Elsbree.

Early attempts to control stormwater with a network of drainpipes and infiltration dry wells backfired as the soil dried out and trees began declining and dying. Furthermore, down-cutting in the ravine bed was causing groundwater to leach out of the steep slopes.

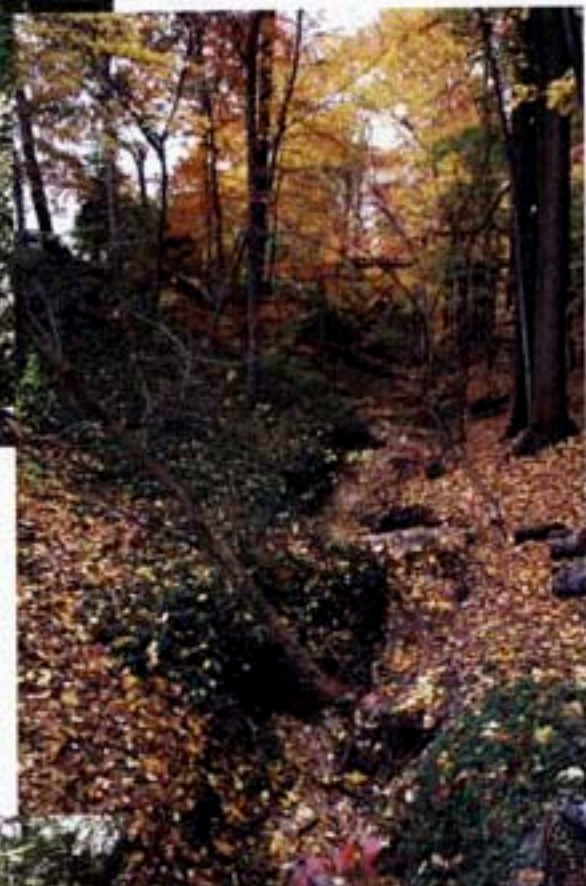
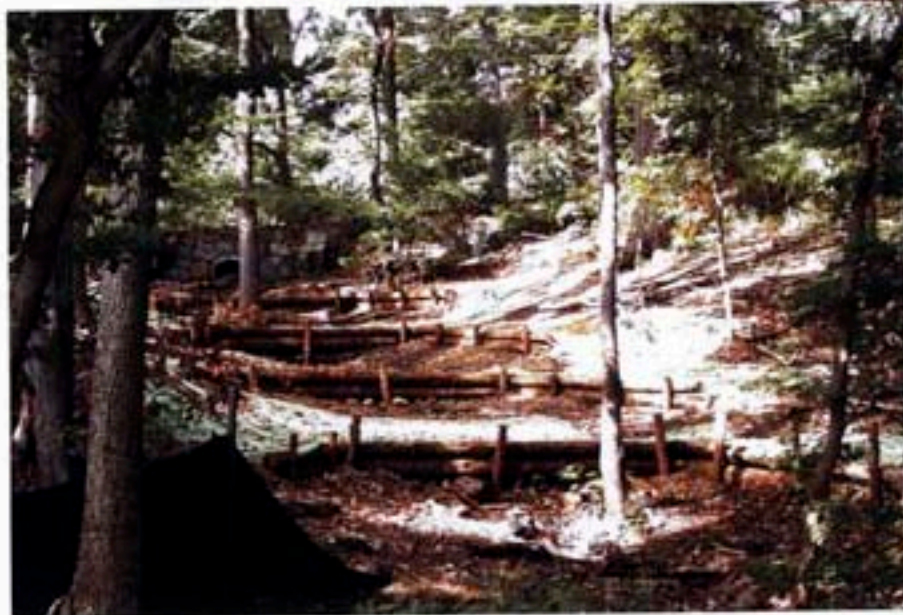
The health of trees and ground-plane plants, top, is improving thanks to the water management system. Parched soil had taken a toll on plant life, above, before the system was installed. Check dams, left, constructed of logs, slow the flow of rainwater in an attractive and unobtrusive manner.

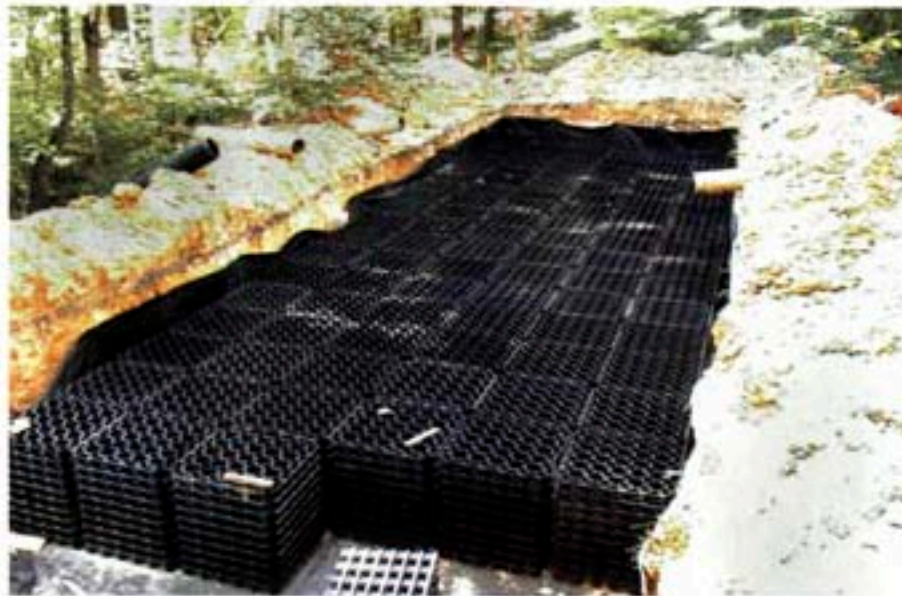
**A large infiltration pit was built to collect runoff, allowing it to seep into the soil rather than directing it off the site as the existing drain pipes had done.**

Infiltration pits were built along the path at intervals of about 50 feet to allow water to gradually disperse into the soil.

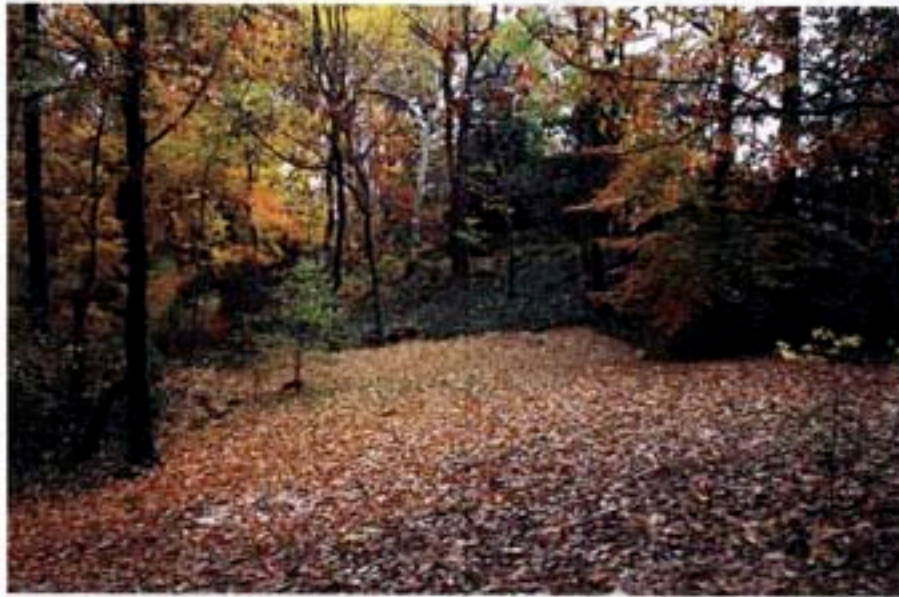
**The completed infiltration pit is not visible to Olmsted Woods visitors, in keeping with the naturalistic aesthetic of the site.**

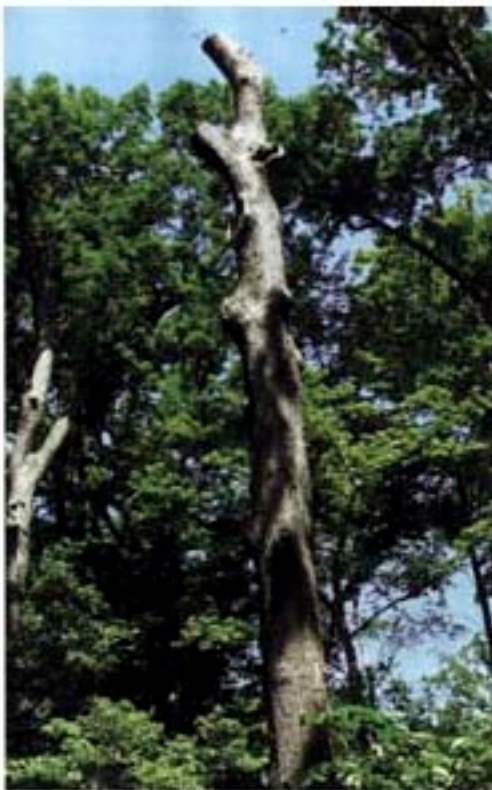
**Trunks of dead trees, shorn of their canopies to avoid wind damage, are left in place to provide habitat for woodpeckers and other wildlife.**

ed along the woodland edge. Wildflowers, ferns, and flowering "spring ephemerals" such as trout lilies, spring beauties, and trillium were planted on the forest floor. Sometimes, though, the desire to maintain ecological habitat wins out over sheer aesthetics. Trunks of dead trees are left in place, and fallen logs, twigs, and branches are left to decay, providing habitat for birds, foxes, and other wildlife.

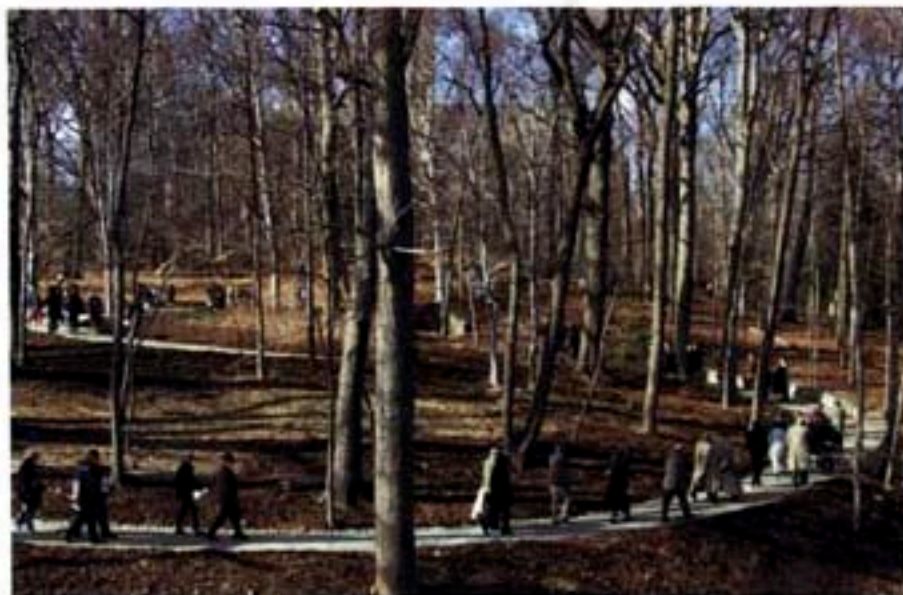
Visitors enjoy the new Pilgrim Way path on its opening day in fall 2000. Before it was installed, foot traffic compacted the soil throughout the site, causing severe stress to trees.

The Pilgrim Way path is in many ways successful. It is attractive, and people keep to the path rather than traipsing across the soil, which has eased compaction problems. "I was a little bit skeptical of Andropogon's claims that if we built the path, people would stay on it," says Luebke, "but they do. It has really changed the mind-set of the people in the community."

The stabilized aggregate, NaturalPAVE, however, while beautiful and natural looking, has not worked out so well on steeper slopes, he says. It has tended to wash away

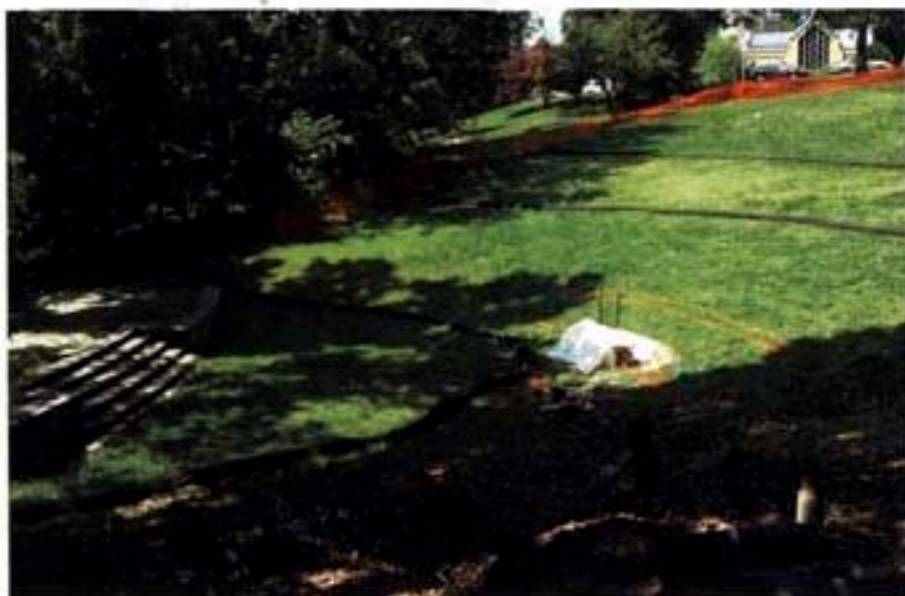
**Renovation of an outdoor amphitheater, to be used for worship services and performances, is the final step in the Olmsted Woods restoration project. It's due to be completed in fall 2006.**

The renovation of the amphitheater, phase three of the project, is also related to water management. In early assessments, it was clear that this uninviting part of the site, with its steep grade, was a significant contributor to runoff problems. A detailed

design has been drawn up by Michael Vergason, FASLA, an adviser to the AHG, and construction recently began. The slope will be irregularly terraced to more closely mimic nature, with a simple installation of stone walls and grass. The amphitheater at Swarthmore College's Scott Arboretum is a model for this aspect of the project.
